Fatalgrams and Fatal Reports

Fatality #29 - October 25, 2007
Fall of Person - California - Cement
Riverside Cement Company - Oro Grande Quarry

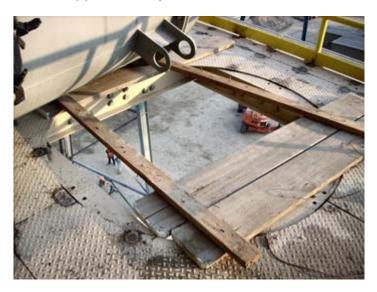
METAL/NONMETAL MINE FATALITY - On October 25, 2007, a 19 year-old contractor ironworker with 20 weeks of experience was fatally injured at a cement operation. The victim was standing on 2 x 10 x 72 inch planks that were nailed to cross members and placed across a 48-inch diameter hole where a duct was to be installed. Several of the planks dislodged and he fell approximately 75 feet.

- Ensure that floor openings are protected by railings, barriers, or covers that are properly constructed, installed securely, and maintained to control all hazards.
- Ensure that areas are barricaded or have warning signs posted at all approaches if hazards exist that are not immediately obvious.
- Examine your work places for all possible hazards and correct them before you perform work.
- Remember and use SLAM: Stop, Look, Analyze, and Manage.
